Re: Notice of Violation  
EPA I.D. No.: INR 000 015 289

COMPLIANCE EVALUATION INSPECTION REPORT

**INSTALLATION NAME:** Superior Fiberglas and Resins

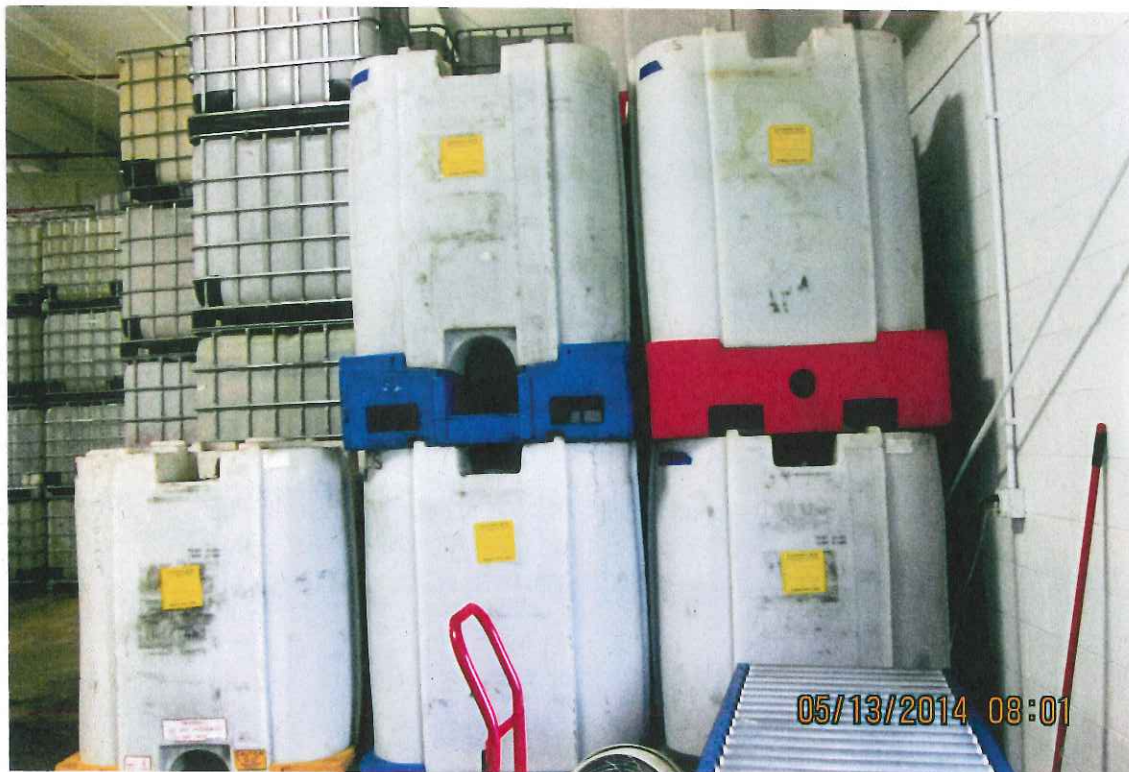
We exited the office conference room and entered the Facility from the west. We proceeded to the north where I visually inspected the hazardous waste tote storage area (see Photograph 1). I observed that the five hazardous waste storage totes were all labeled and dated appropriately (see Photograph 2). As noted on the diagram, a spill kit was located adjacent to the storage area (see photograph 3).

PHOTOGRAPH 1 of 12: Hazardous waste tote storage northwest corner of building (facing south).

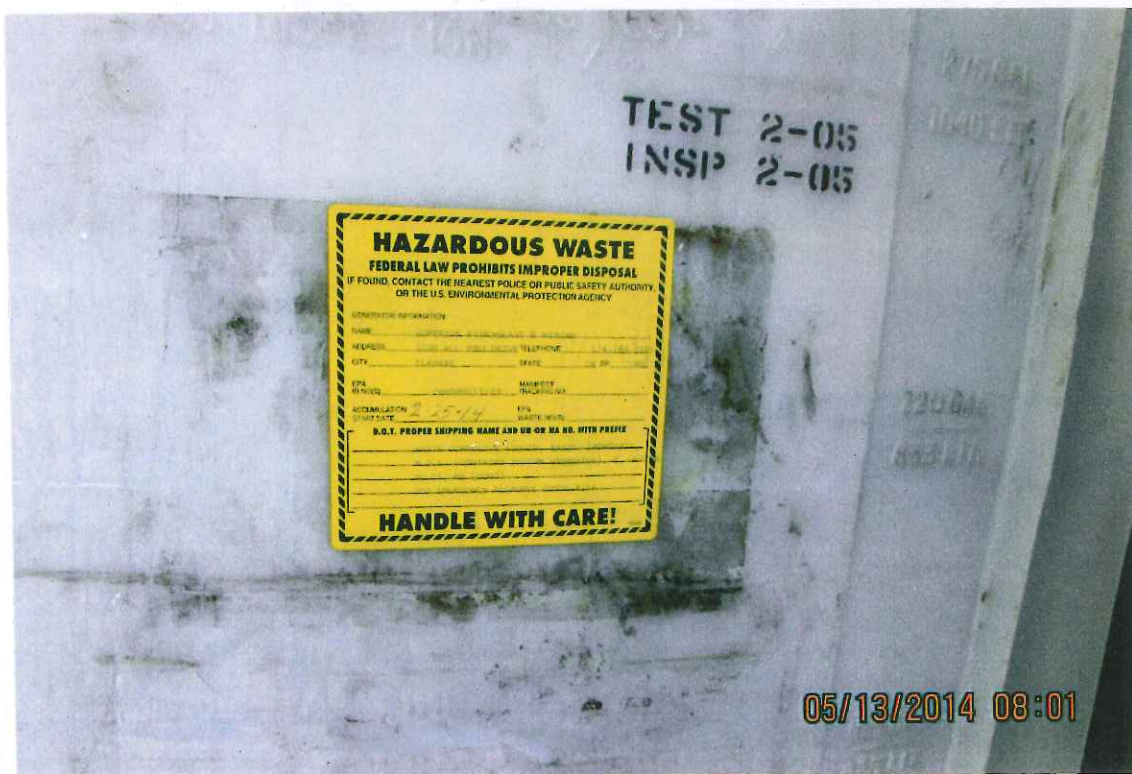
PHOTOGRAPH 2 of 12: Hazardous waste tote label (facing south).

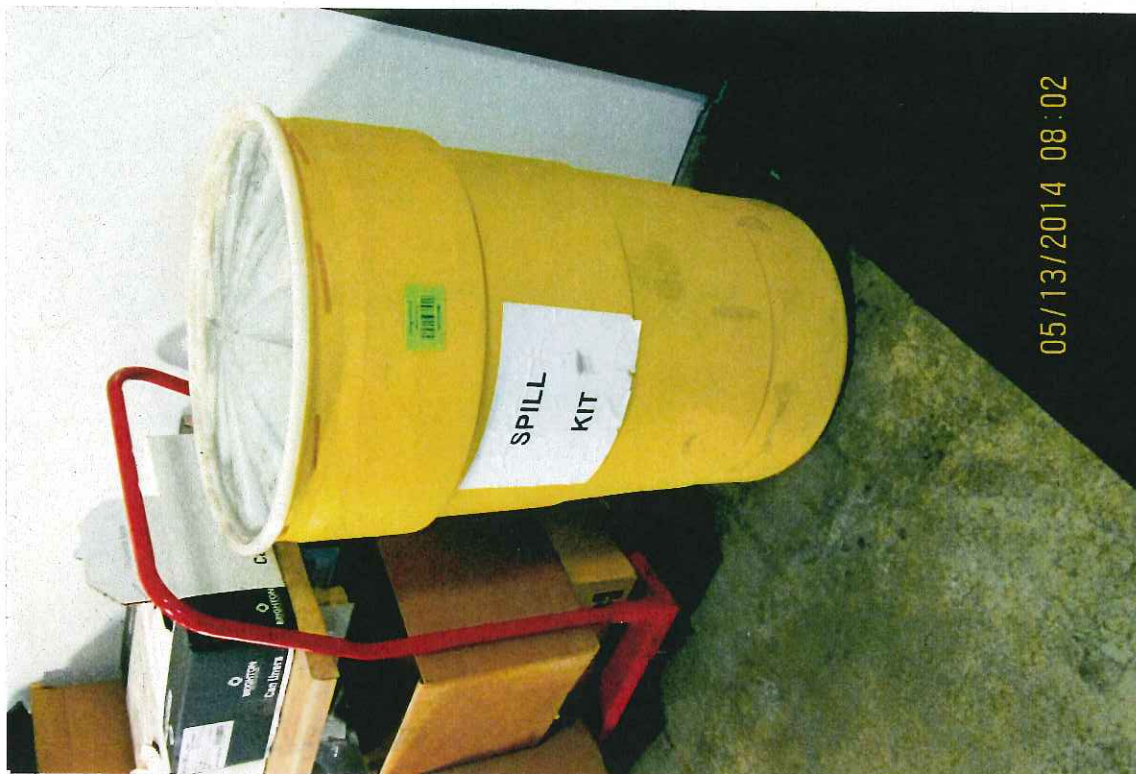
PHOTOGRAPH 3 of 12: Spill Kit southeast of hazardous waste tote storage (facing southwest).

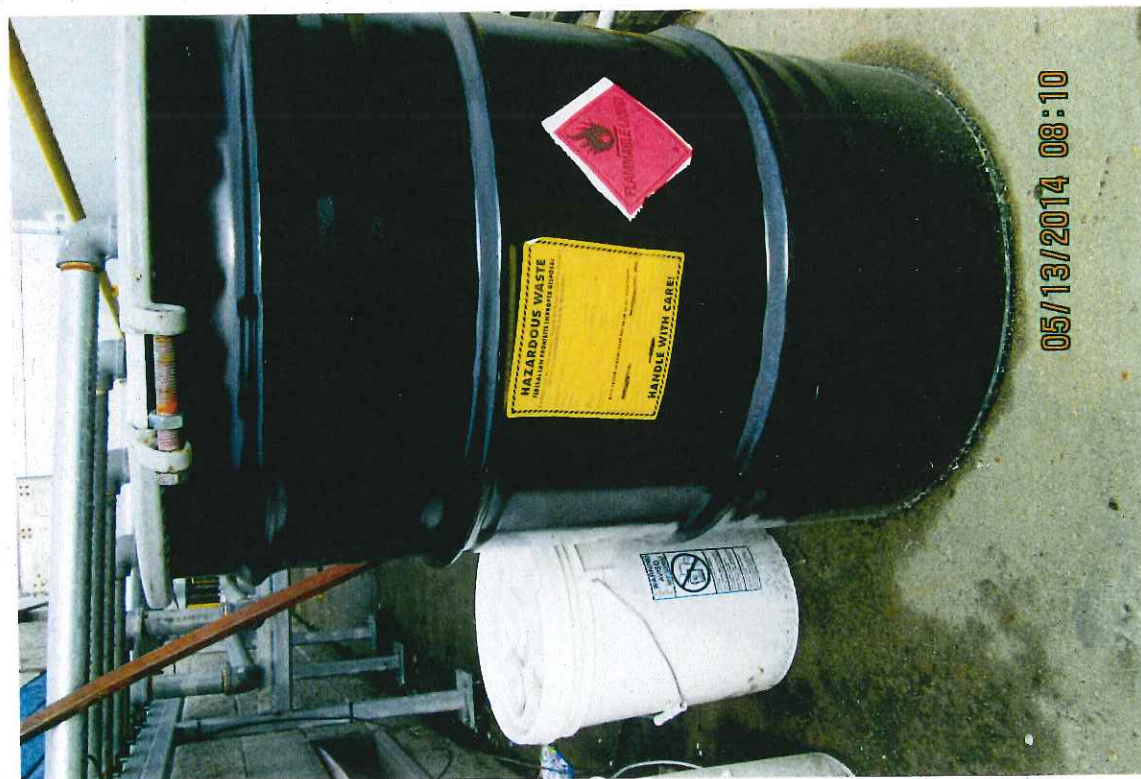
We proceeded east and exited the building to the north. I visually inspected the west and north side of the building, and then we walked through the exterior Trailer Parking and Product Tank area. I noted one hazardous waste satellite accumulation container at the northeast corner of the building adjacent to Product Tank 1 (see Photograph 4). I noted that the hazardous waste satellite accumulation container was properly labeled and closed when not in use.

PHOTOGRAPH 4 of 12: Hazardous waste satellite accumulation container at northeast corner of building near Tank 1 (facing west).

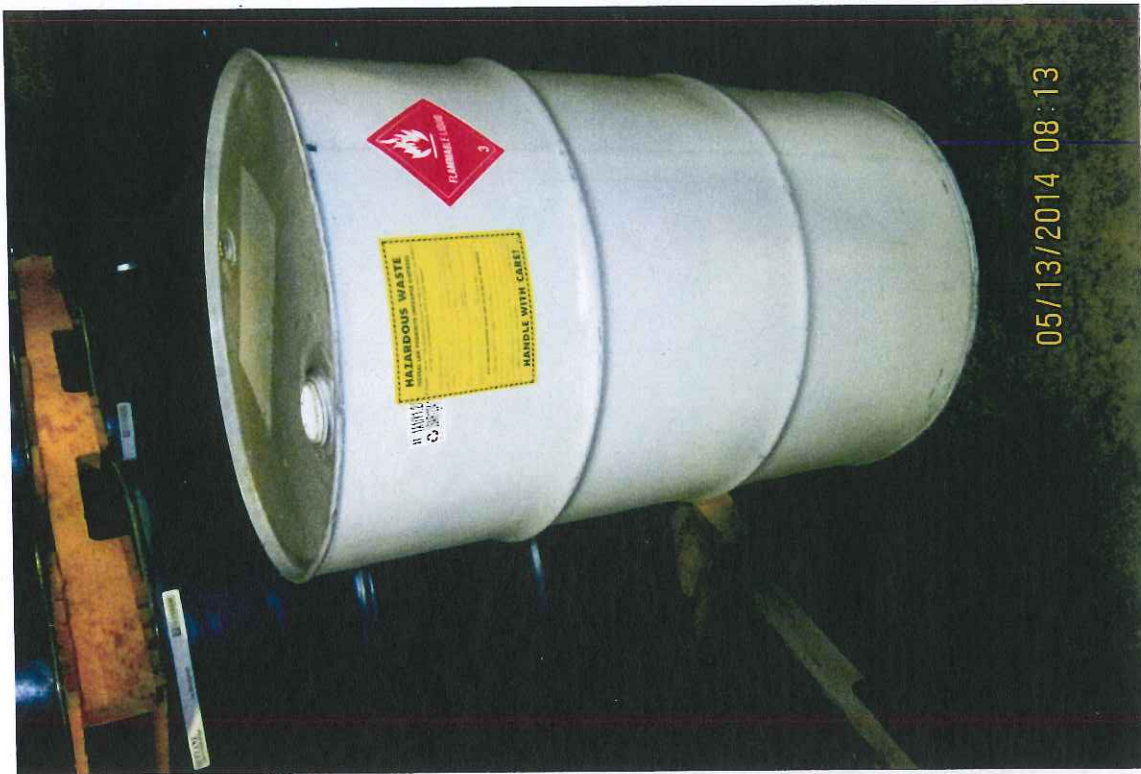
We re-entered the building and walked to the west along the Flammable Drumming area. I observed one hazardous waste satellite accumulation container in the Flammable Warehouse (see Photograph 5), and one hazardous waste satellite accumulation container near Flammable Drumming (see Photograph 6). I noted that both hazardous waste satellite accumulation containers were properly labeled.

PHOTOGRAPH 5 of 12: Hazardous waste satellite accumulation container in drumming area (facing northeast).

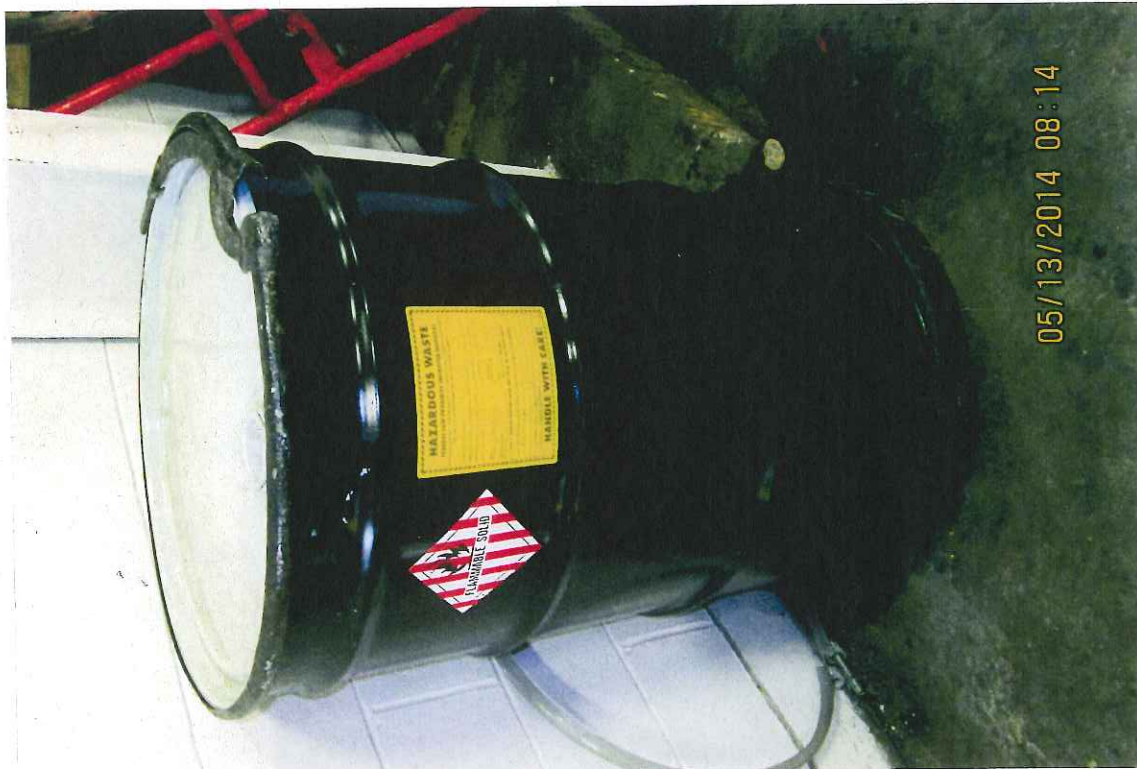
PHOTOGRAPH 6 of 12: Hazardous waste satellite accumulation container at corner of flammable drumming (facing northeast).

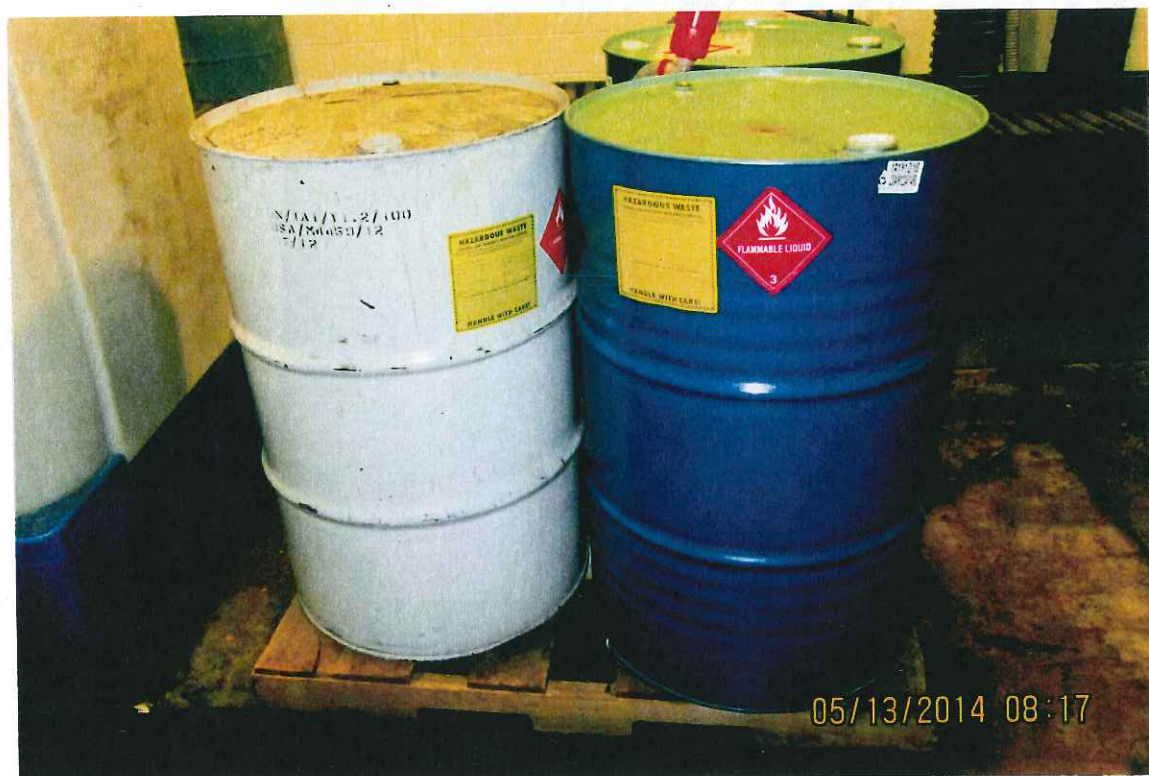
We turned north and proceeded to the Tote Cleaning Area. I noted two hazardous waste satellite accumulation containers (see Photograph 7). I noted that both hazardous waste satellite accumulation containers were properly labeled (see Photographs 8 and 9). I also noted a grate in front of the two hazardous waste satellite accumulation containers (see Photograph 10). I noted that pit beneath the grate was empty. Mr. Brown explained that the Tote Cleaning Area (see Photograph 11) and the grated pit are self-contained and any material in the containment from Tote Cleaning is immediately removed.

PHOTOGRAPH 7 of 12: Two 55-gallon hazardous waste satellite accumulation containers in tote cleaning area (facing north).

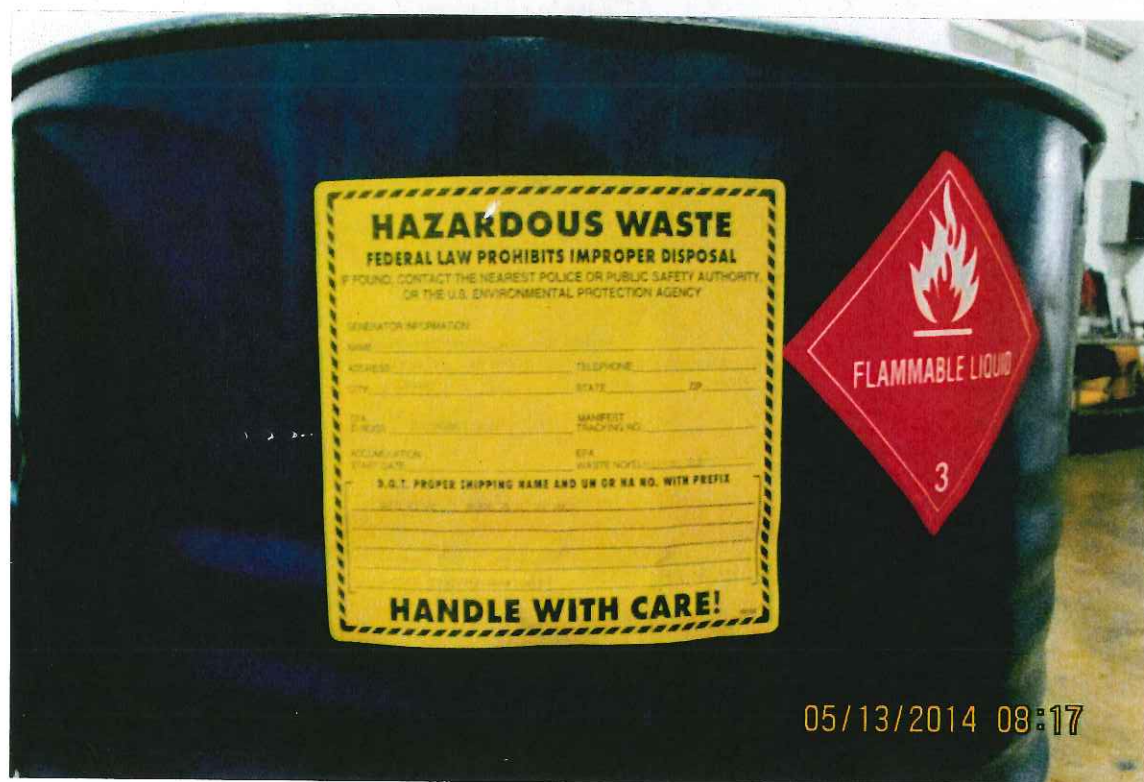
PHOTOGRAPH 8 of 12: Label on blue 55-gallon hazardous waste satellite accumulation container in tote cleaning area.

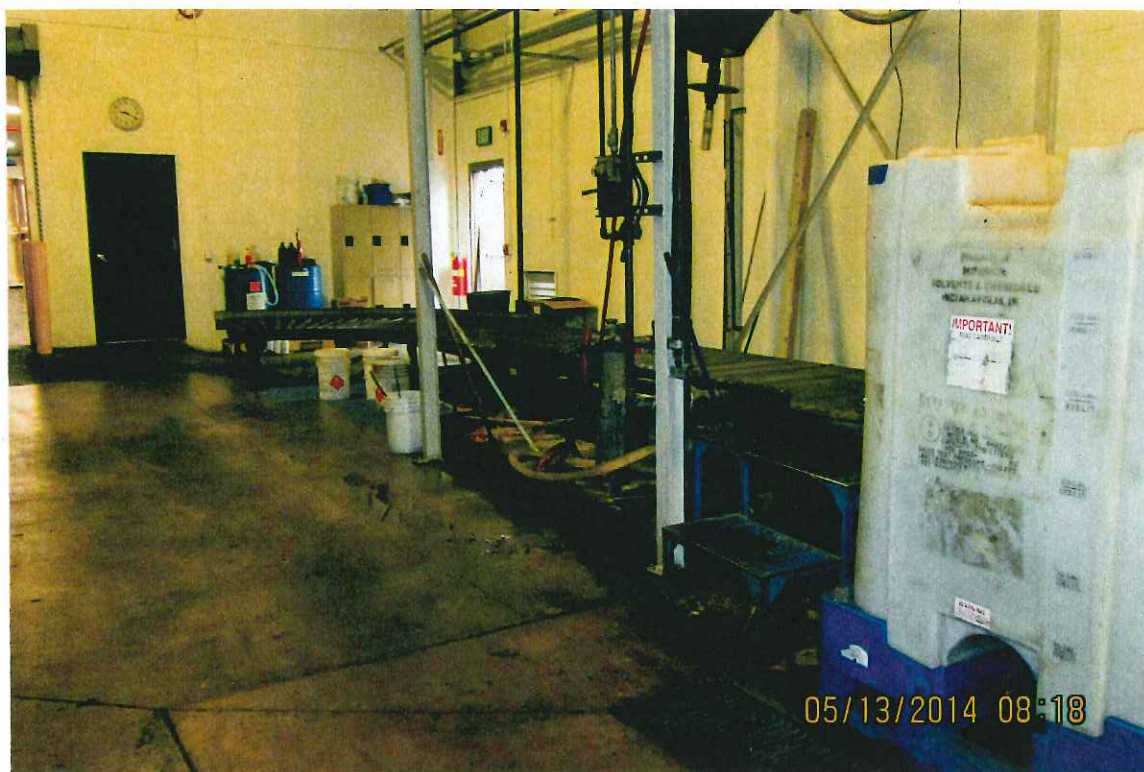
PHOTOGRAPH 11 of 12: Tote cleaning area along north wall (facing northwest).

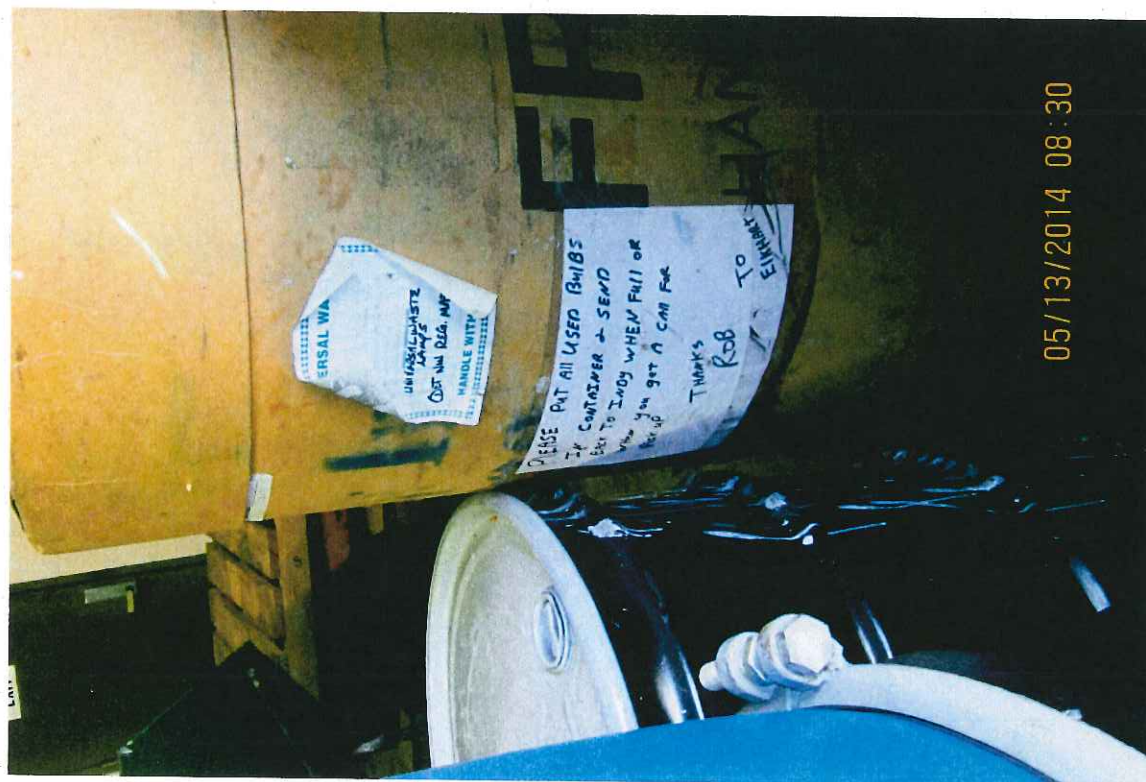
From the Tote Cleaning Area we proceeded south to the loading areas. I noted one container of universal waste lamps (see Photograph 12) in the corner between the Organic Peroxide Storage Room and the Front Loading Docks. I noted that the universal waste container was properly labeled (though starting to peel off) and the container was closed. We then exited the Drum and Tote Storage Area and returned to the Office Conference Room.

PHOTOGRAPH 12 of 12: Universal waste lamps near overhead door on south side of building (facing southeast).
